**Flood Control Project Maintenance
Levee Inspections****LMA District Cover Sheet****Spring 2013 Levee Inspection Results****Reclamation District No. 2068 Yolano**

Spring 2013 Levee Inspection Results

Reclamation District No. 2068 Yolo

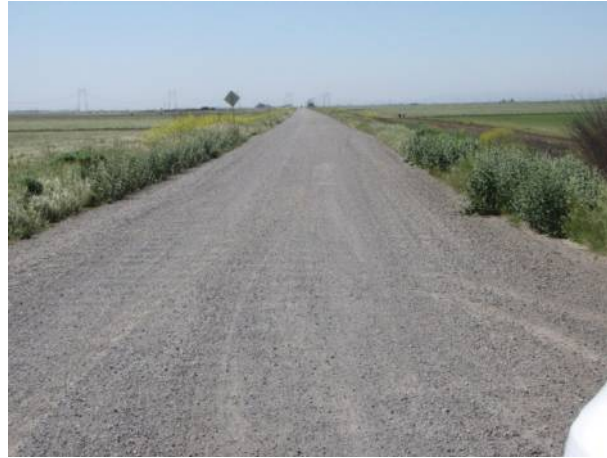
phillips_s_20130513_425.JPG

| LMR No. | Levee Mile | | Category | Item | Location * + Rating | Action/Comment | GPS Latitude/Longitude | | Issue No. Photo |
|---|---|---|---|---|---|--|---|---|---|
| 5 | 0.51 | 0.51 | | Vegetation | LS M Ma | V2 : Remove the wild growth other than native grasses from the levee slopes. Inspector Comments: The District is scheduled to burn the levee slopes during the summer month as they always do, however during my inspection the growth was present. 4-2013. | 38.401240 ° -121.693732 ° | 38.401240 ° -121.693732 ° | 12 Y |

RD 2068, standing at levee mile 0.51 looking downstream growth on both slopes. Photo taken 4-23-2013.

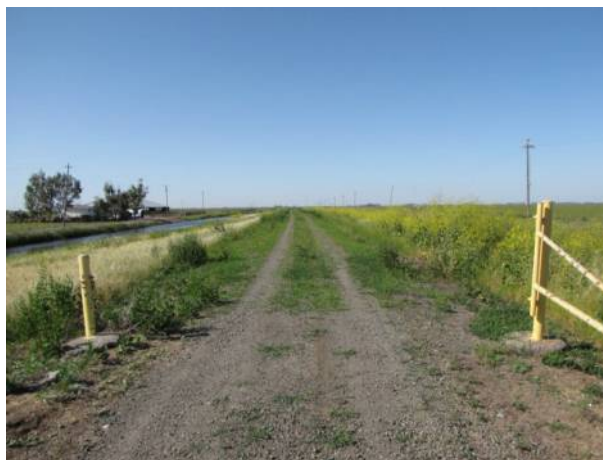
dpesaven_s_20130516_427.JPG

| LMR No. | Levee Mile | | Category | Item | Location * | Rating + Ma | Action/Comment | GPS Latitude/Longitude | | Issue No. Photo |
|---|---|---|---|---|---|---|--|---|---|---|
| 1 | 0.00 | 0.27 | | Vegetation | LS | M Ma | V2 : Remove the wild growth other than native grasses from the levee slopes. | 38.358235 ° -121.740392 ° | 38.362138 ° -121.740339 ° | 1 Y |

RD 2068 unit 2 looking downstream from levee mile 0.00 view of both slopes and crown roadway. Photo taken 4-23-2013.
